Report on Geotechnical Pavement
Investigation

**Spring Lake North
Pavements
Independence Township,
Michigan**

G2 Project No. 243572
September 5, 2024

RE: Report of Geotechnical Pavement Investigation
Spring Lake North Pavements
Adderstone Drive, Berwick Drive, Berwick Court, Golf View Drive, Ancroft Drive, Ancroft Court,
And Campfire Circle
Independence Township, Michigan
G2 Project No. 243572

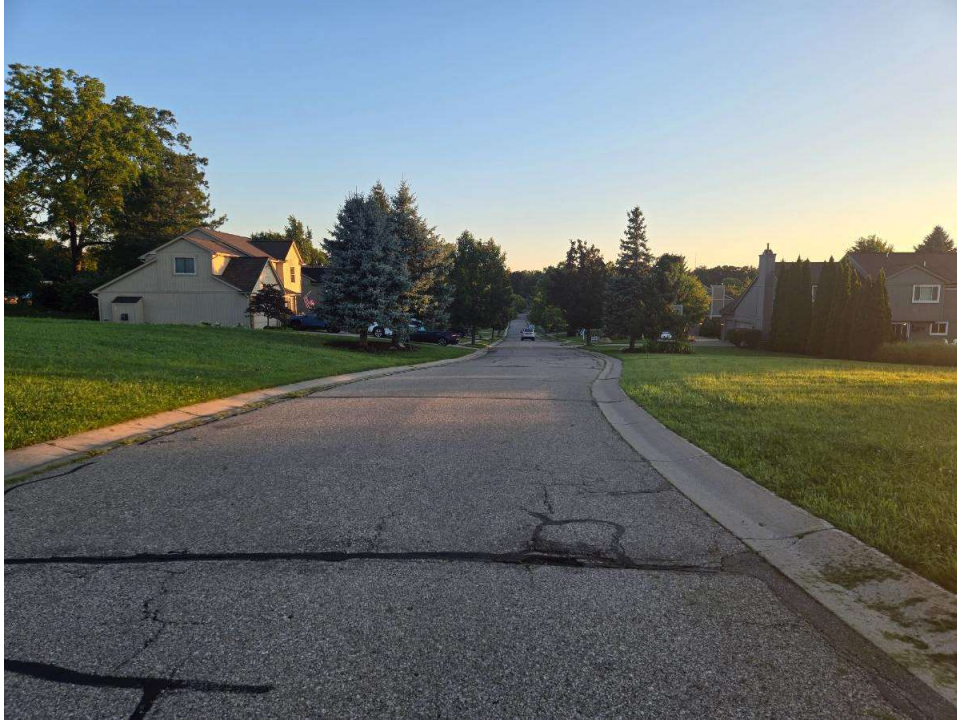
Photograph No. 1: Moderate severity transverse and secondary cracking with crack sealing along Adderstone Drive near boring B-01. View to the north.

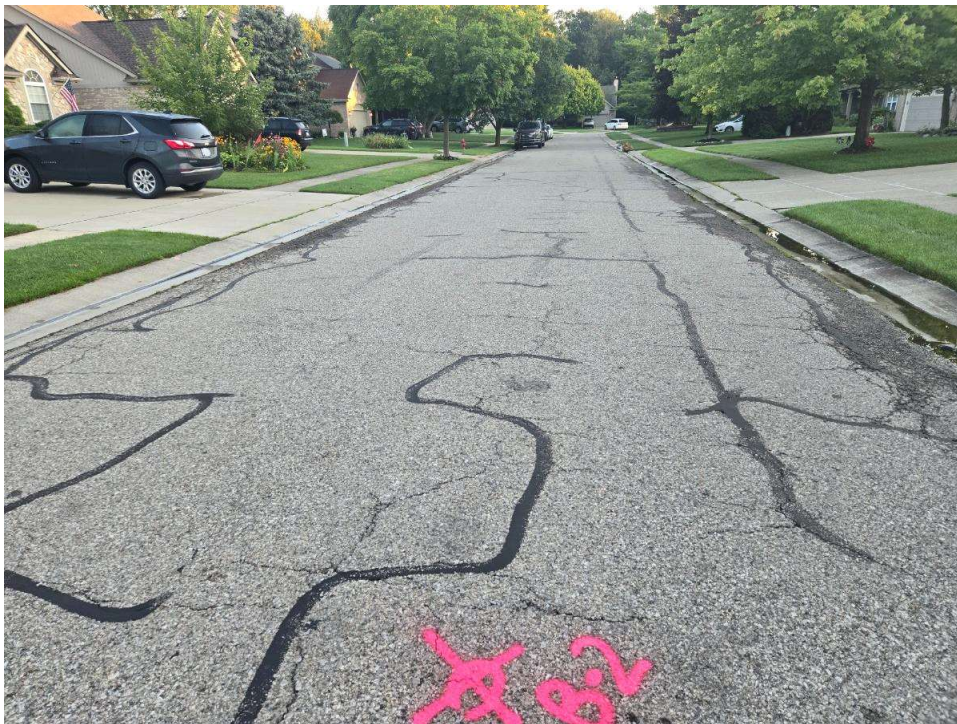
Photograph No. 2: Low to moderate severity longitudinal, transverse, and edge cracking with crack sealing along Adderstone Drive near boring B-02. View to the north.

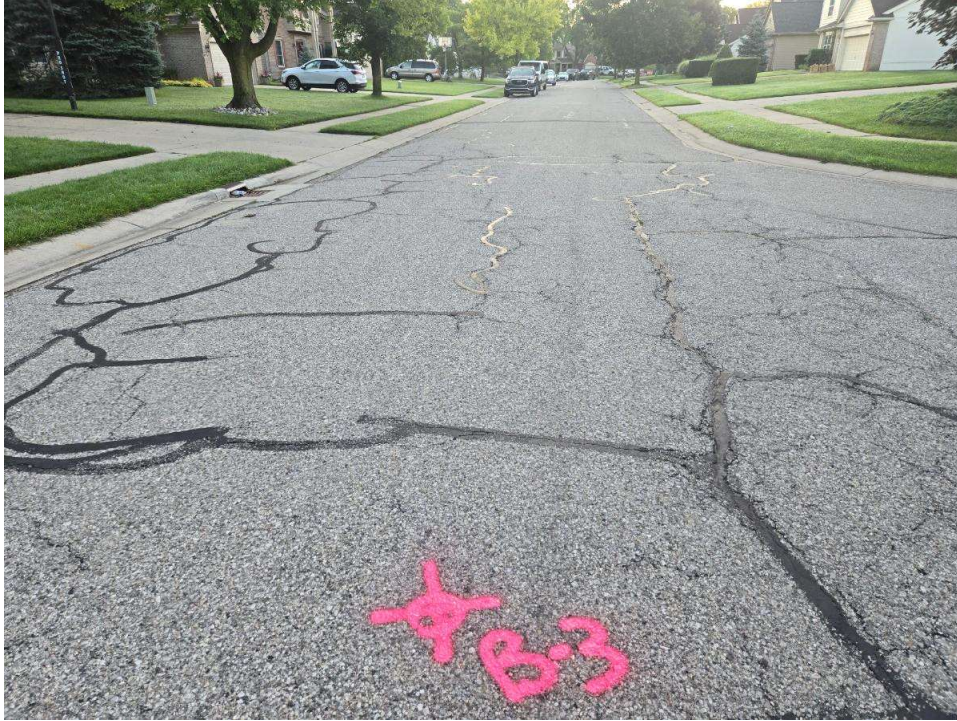
Photograph No. 3: Moderate severity longitudinal and fatigue cracking crack sealing along Berwick Drive near boring B-03. View to the east.

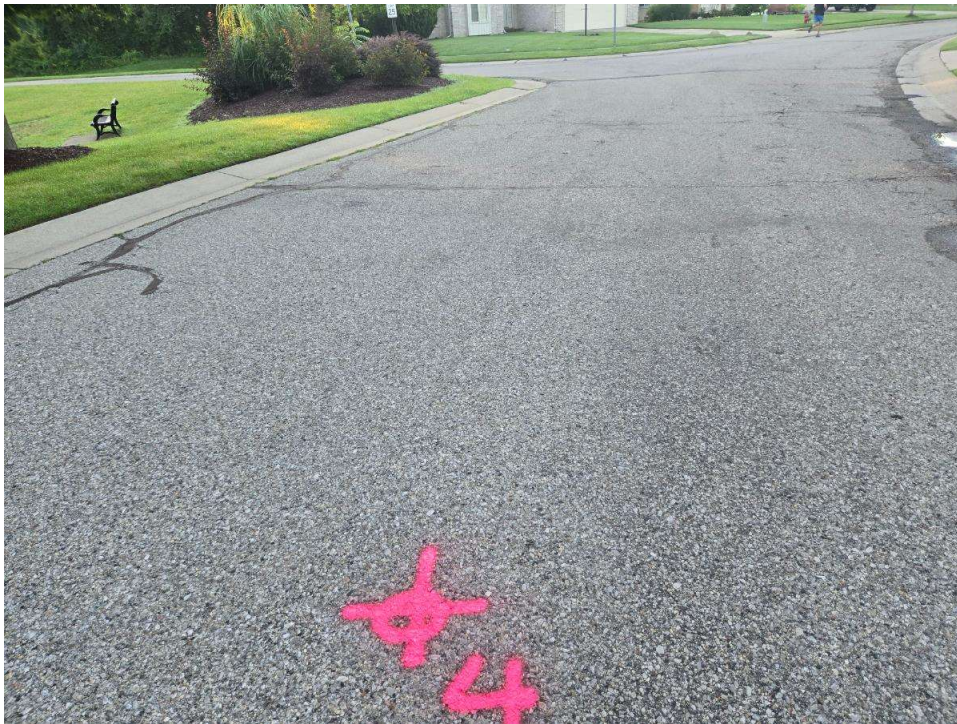
Photograph No. 4: Low severity edge and transverse cracking with crack sealing along Berwick Drive near boring B-04. View to the southeast.

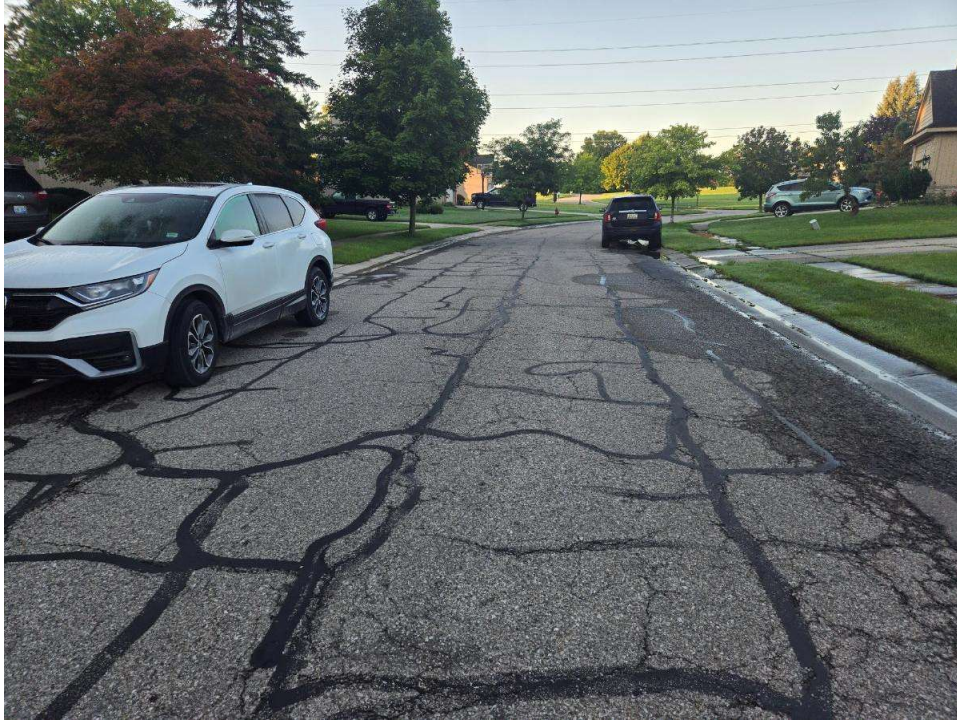
Photograph No. 5: Moderate to high severity transverse, longitudinal, secondary, and edge cracking with crack sealing along Berwick Drive near boring B-05. View to the south.

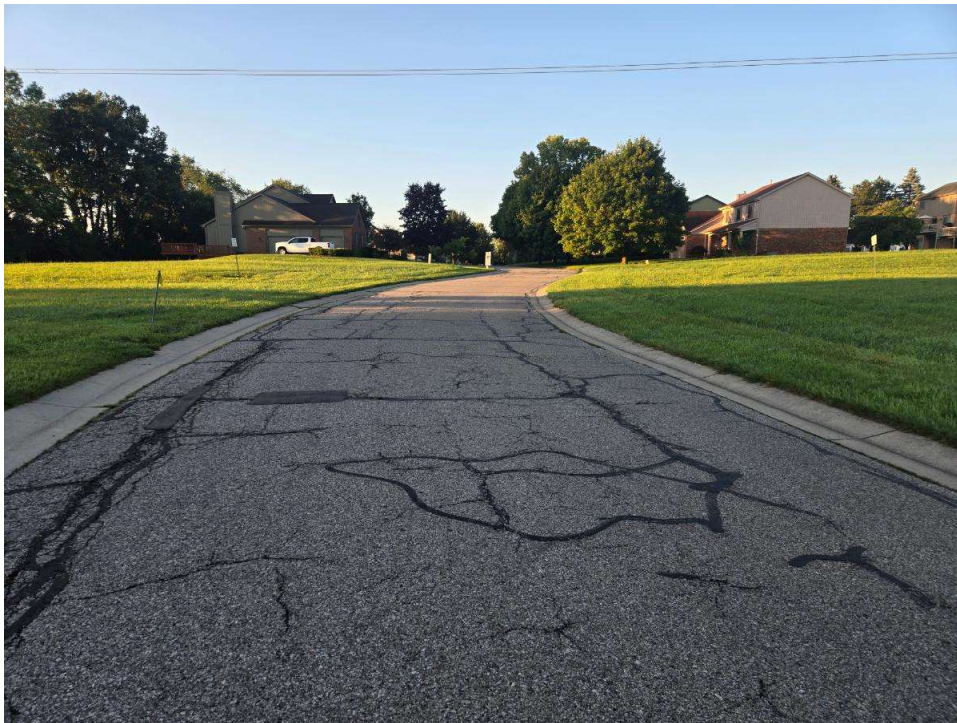
Photograph No. 6: Moderate severity transverse, longitudinal, secondary, and edge cracking with crack sealing along Golf View Drive near boring B-06. View to the south.

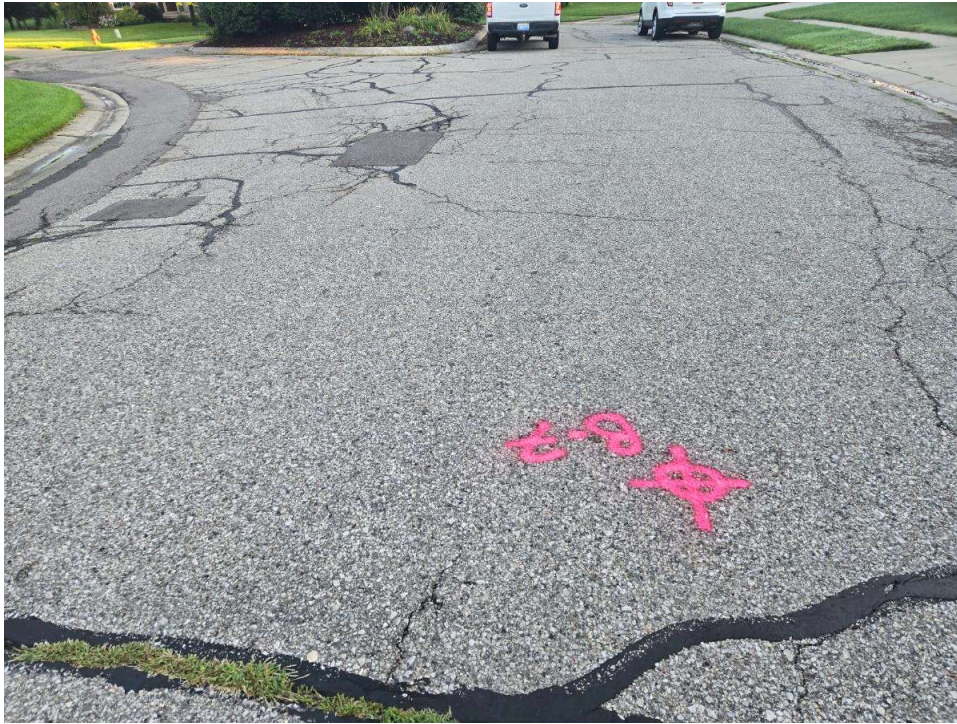
Photograph No. 7: Moderate to high severity transverse, fatigue, and secondary cracking with surface patching and crack sealing along Ancroft Court near boring B-07. View to the north.

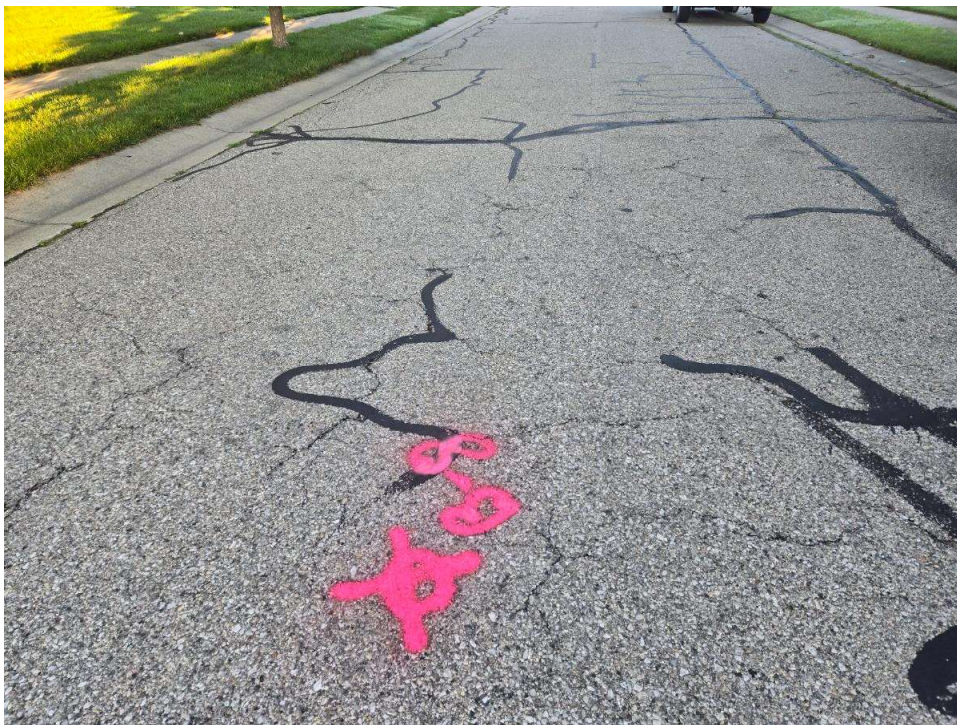
Photograph No. 8: Low to moderate severity transverse, longitudinal, and secondary cracking with crack sealing along Ancroft Drive near boring B-08. View to the west.

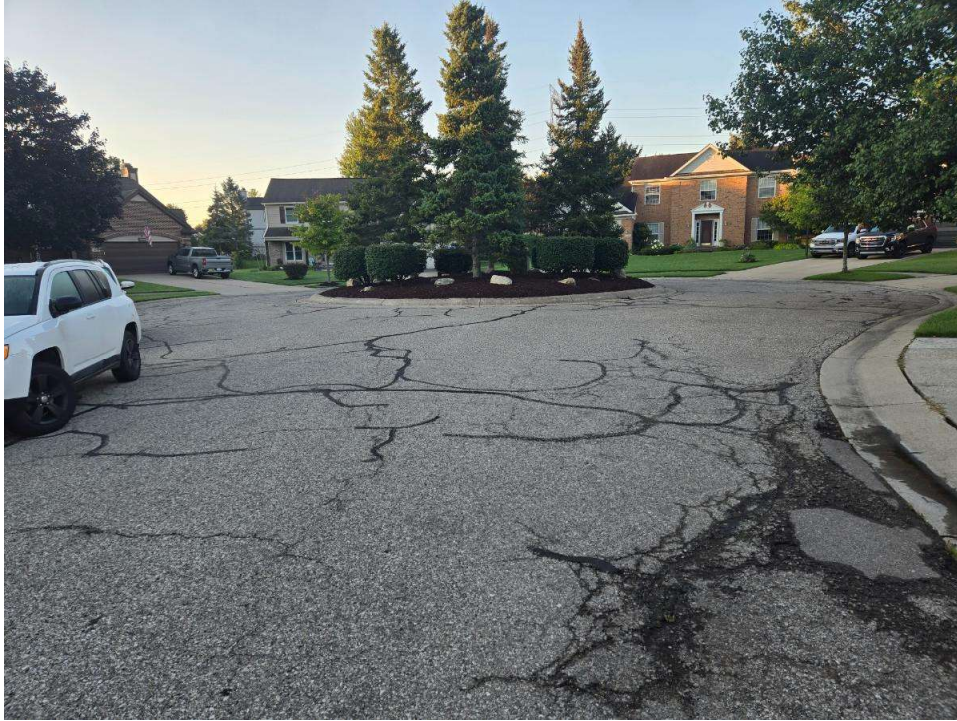
Photograph No. 9: Moderate severity longitudinal, transverse, and edge cracking with cold patching and crack sealing along Berwick Court near boring B-09. View to the south.

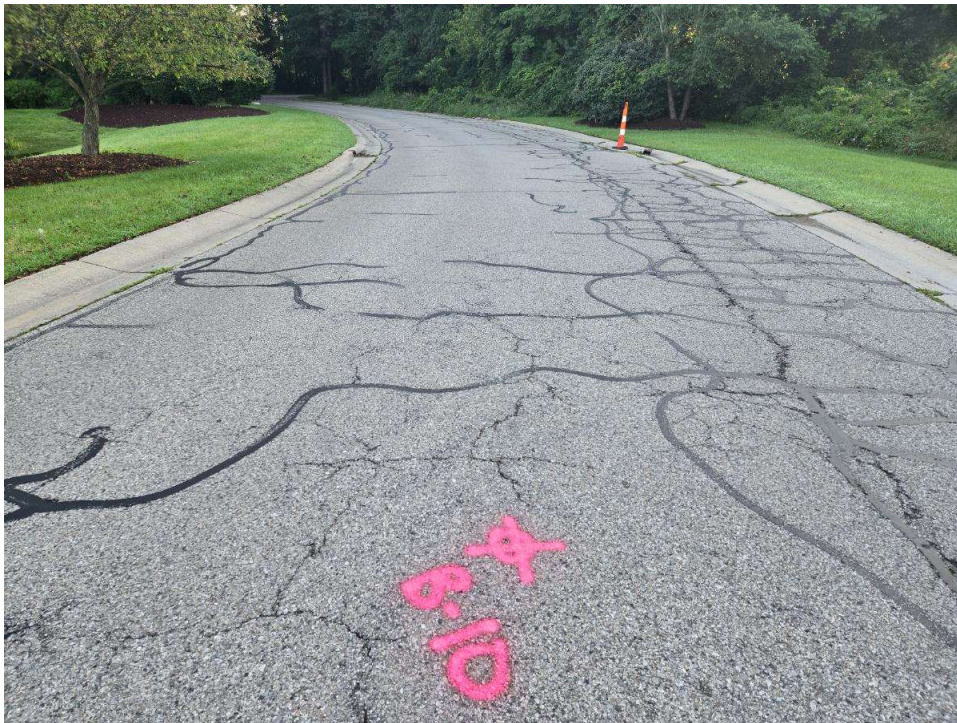
Photograph No. 10: Moderate to high severity longitudinal, transverse, and secondary cracking with crack sealing along Campfire Circle near boring B-10. View to the northeast.
